# Manhole Inspection Summary

Manhole # S21I\_\_012MH

Insp Date: **9/21/07 10:48 AM**

**Location** Address: **46 ADDISON-FULTON**

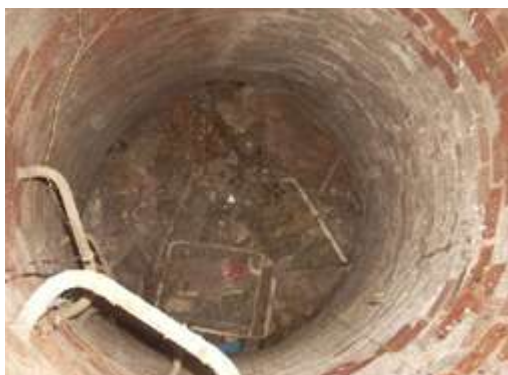
Top View

2 WAY TERMINAL HAS O12 AND O3  
PIPES CLEARLY VISIBLE IN PHOTO

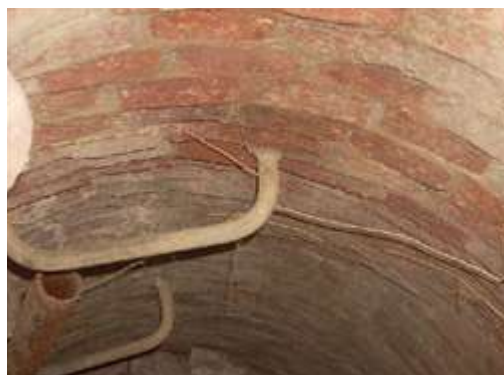
Defect 3

Condition: ☐ Sound ☐ Cracked ☒ **Root Intrusion** ☐ Loose Brick ☐ Deteriorated

ROOT INTRUSION OF THE BARREL

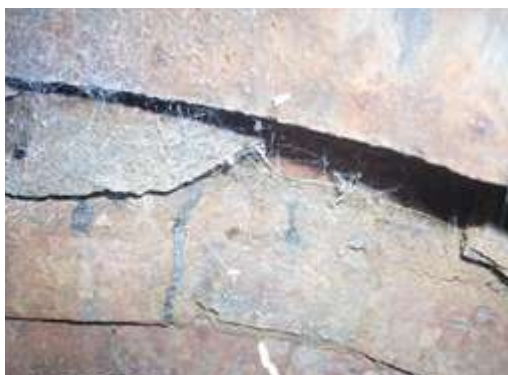
Defect 2

Condition: ☐ Sound ☐ Cracked ☐ Root Intrusion ☐ Loose Brick ☒ **Deteriorated**

DETERIORATED CORBEL

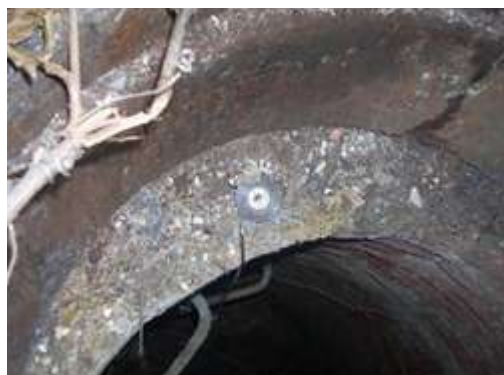
Defect 1

**Frame** Offset: **3** (in.) Condition: ☒ Sound ☐ Cracked ☐ Leaks

FRAME OFFSET

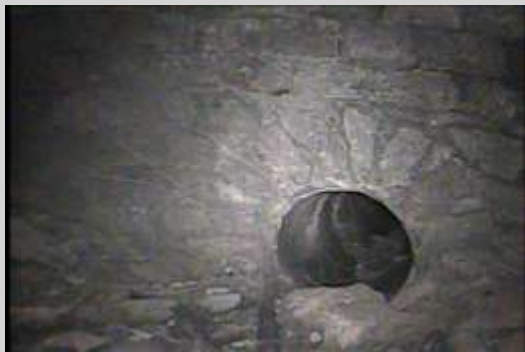
12 O'Clock Outflow

8 in. Circular Gravity Sewer  
Pipe Out @ 12 O'Clock

Pipe Height: **8.4** (in.) Rod and Bar (Angled)  
Pipe Material: **Clay** ☐ Pipe Lined  
Invert Depth: **9.29** (ft.) Flow Characteristics: **None**  
Deposits: ☐ None ☐ Mud ☐ Sludge ☒ **Debris** ☐ Grease  
Silt Depth: **1** (in.) Deposits Extent: **Light**  
Infiltration: **None** Pipe Seal Cond: **Sound**

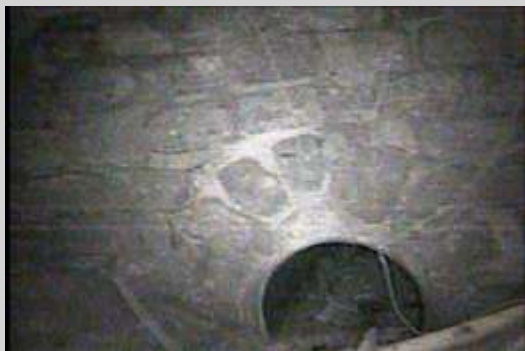
3 O'Clock Outflow

8 in. Circular Gravity Sewer  
Pipe Out @ 3 O'Clock

Pipe Height: **7.2** (in.) Rod and Bar (Angled)  
Pipe Material: **Clay** ☐ Pipe Lined  
Invert Depth: **9.58** (ft.) Flow Characteristics: **None**  
Deposits: ☐ None ☐ Mud ☐ Sludge ☒ **Debris** ☐ Grease  
Silt Depth: **1** (in.) Deposits Extent: **Light**  
Infiltration: **None** Pipe Seal Cond: **Sound**
